Edmonton, Canada

ALBERTA UTILITY AVERTS POTENTIAL CATASTROPHIC HOLIDAY FAILURE WITH PROACTIVE PIPELINE MANAGEMENT APPROACH

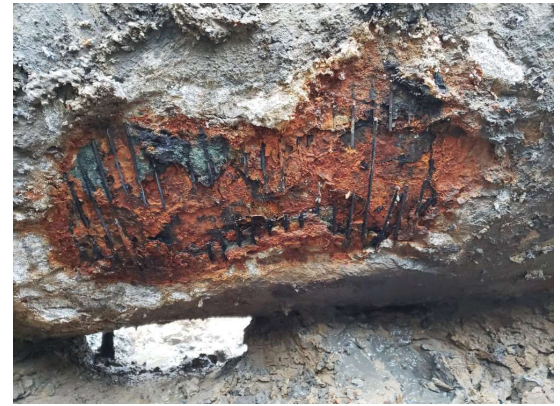
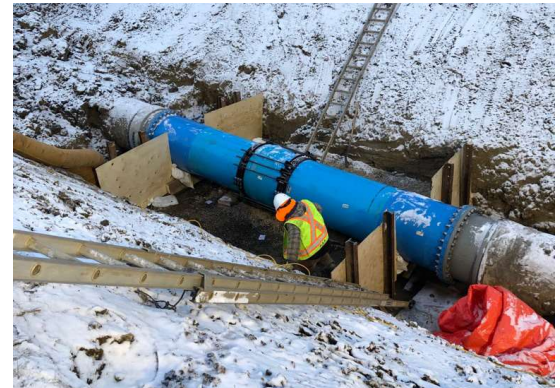
In early December 2019, as the busy and frigid holiday season quickly approached, Pure Technologies alerted EPCOR to a high-risk pipe section with both broken wire wraps and a leak on the pipe barrel. Data from both the SmartBall and PipeDiver platforms clearly showed the location of the damaged pipe between two elbows.

EPCOR weighed their options and decided to proactively repair the pipe. After excavation, Pure Technologies verified both the leak and wire wrap damage. EPCOR successfully executed an emergency repair on the pipe, averting a potential catastrophic failure just in time for the holiday season.

EPCOR conducted an emergency repair on this high-risk pipe in December 2019. Inspections identified a leak on the pipe barrel and broken wire wraps.
