I See Multibeam Artifacts! Your Software Doesn't Work!

By Mike Kalmbach

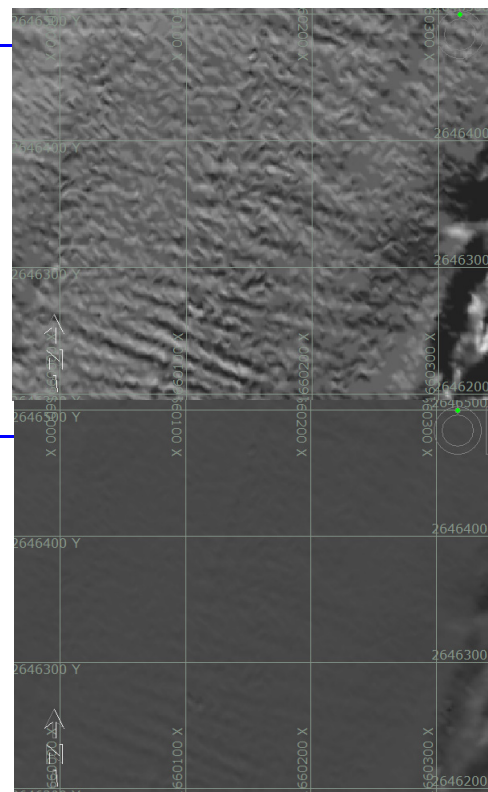
FIGURE 1. Sample Artifacts--15X Vertical Exaggeration

Figure 1 shows a multibeam survey with artifacts that show up clearly with 15x vertical exaggeration. It looks pretty bad. Vertical exaggeration is a good way to pull out artifacts that are not easy to see at normal scale.

First, a reality check. What does it look like without exaggeration? That's shown in Figure 2. The artifacts are not nearly as obvious, but you can see them with just the right angle of artificial illumination.

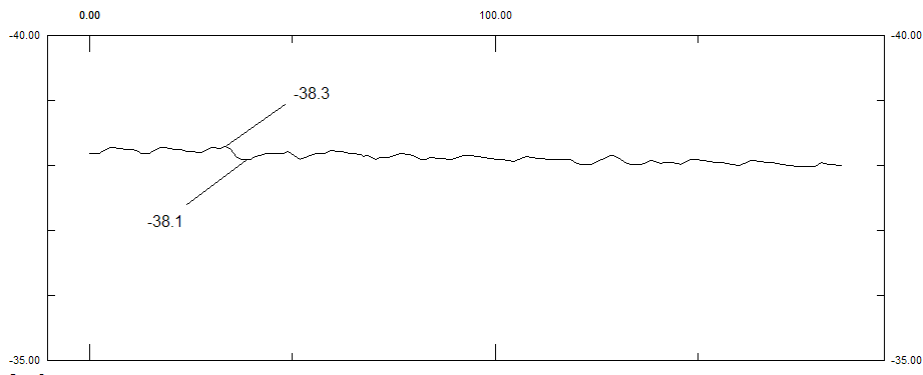
FIGURE 3. Cross Section of Area with Supposed Artifacts - 20X Vertical Exaggeration

Here is the cross section, with 20x exaggeration. There are the artifacts and the magnitude is \pm a tenth of a foot or 3 centimeters.

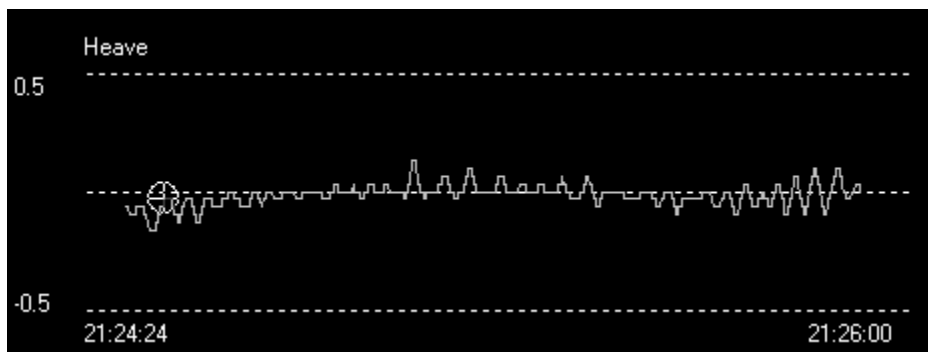
FIGURE 4. Heave Graph

The heave graph looks at bit odd, with a long period oscillation that is probably not right. An artifact in the heave measurement. Turns out the heave was ignored in processing anyway. Instead, heave was measured by vertical GPS movement. That's a questionable strategy if you're chasing tenths, but in this case it seems valid. (i.e., the magnitude and phase of heave and vertical GPS motion match well and GPS update rate is fairly high – about 20 Hz.)

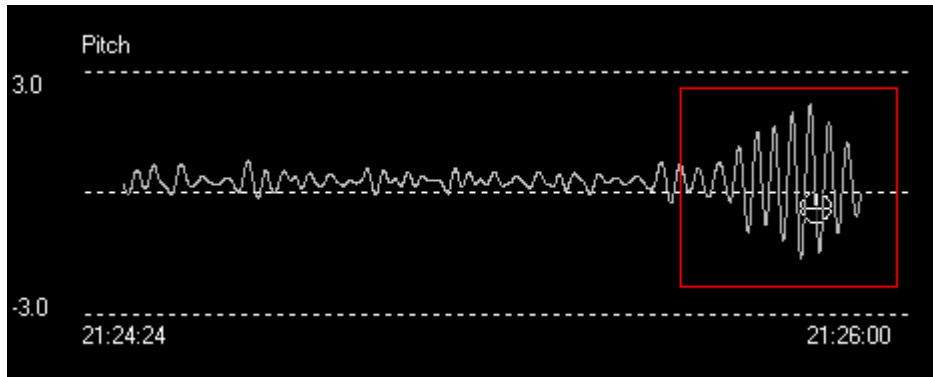
FIGURE 5. Pitch Graph

The pitch graph shows a burst at the time of the depth artifacts. Probably crossing a wake. Given that the lever arm between boat reference and the sonar head is very small, there's no change in sonar draft (a possible source of artifacts).

What's the published heave accuracy of the Octopus F180? 5 cm. RTK vertical? 2 to 20 cm, depending on configuration. Enough to explain the depth artifacts.

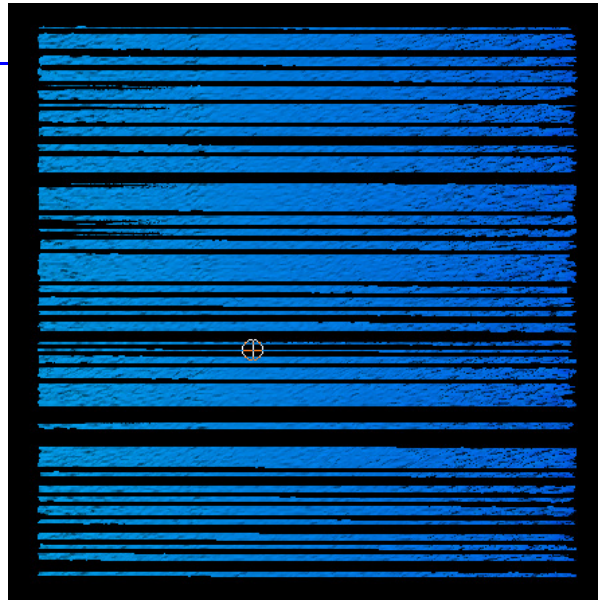
FIGURE 6. Map View of Depths at Time of Supposed Artifacts

Figure 6 shows depths in map view at the time of the artifacts. Each gap is a point where the sonar lost bottom tracking. Clearly it was having trouble! Could that contribute to artifacts? Sure.

At this point, we at HYPACK® have gone as far as we can. Yes, there are artifacts in the data. They are very small. The artifacts are within the accuracy range of the motion sensor. The sonar was having trouble with bottom tracking at the time. Plenty of ways to explain the artifacts.
