# POSMV v5 Group 3 Issue/Resolution

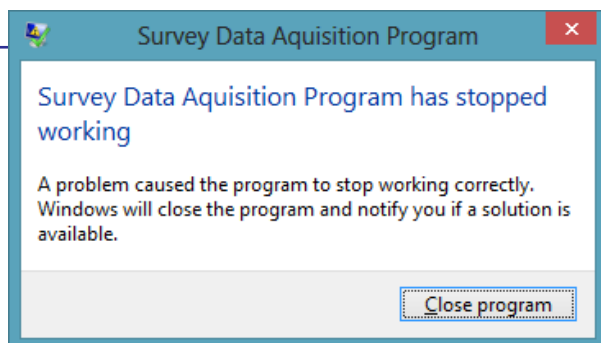
HYPACK® users who use an Applanix POS MV version 5 with BD982 GNSS receiver boards, might experience a HYPACK® SURVEY crash (Figure 1).

**FIGURE 1.** HYPACK Survey Crash Error

This is currently exclusive to new POSMV version 5 units equipped with BD982 GNSS receiver boards and the recent GNSS receiver firmware (v4.84) for these boards. The latest firmware was updated to support the Chinese BeiDous GNSS satellites. With the addition of these satellites, and selecting "Get solution from group 3" in the HARDWARE POSMV setup (Figure 2), the HYPACK® buffer used to store the Group 3 information was too small and HYPACK® SURVEY would crash. HYPACK has now increased the buffer in the latest POS MV driver to accommodate the additional satellite information.

If you are experiencing an instant HYPACK® SURVEY crash, have DB982 GNSS receivers with firmware 4.84, and using Group 3, please go to the HYPACK website and download posmv.dll v14.0.6.13.

If you have not upgraded to HYPACK® 2014 yet and are still using HYPACK® 2013 or 2013a you will also need to install an ownnextp.dll. Please contact [help@hypack.com](mailto:help@hypack.com) for this file or if you have any questions.

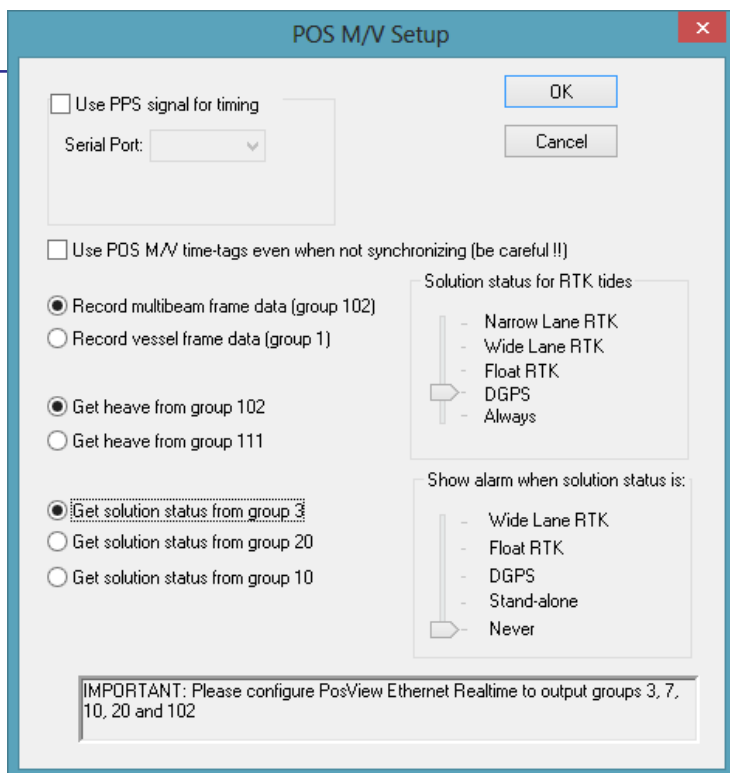
**FIGURE 2.** HYPACK HARDWARE - POSMV Setup with Group 3 Selected
