## Case Study:

### VANCOUVER INTERNATIONAL AIRPORT, VANCOUVER, B.C.

*Pipeline inspection to manage the critical watermain for a busy international airport takes months of proactive planning, safety and scheduling.*

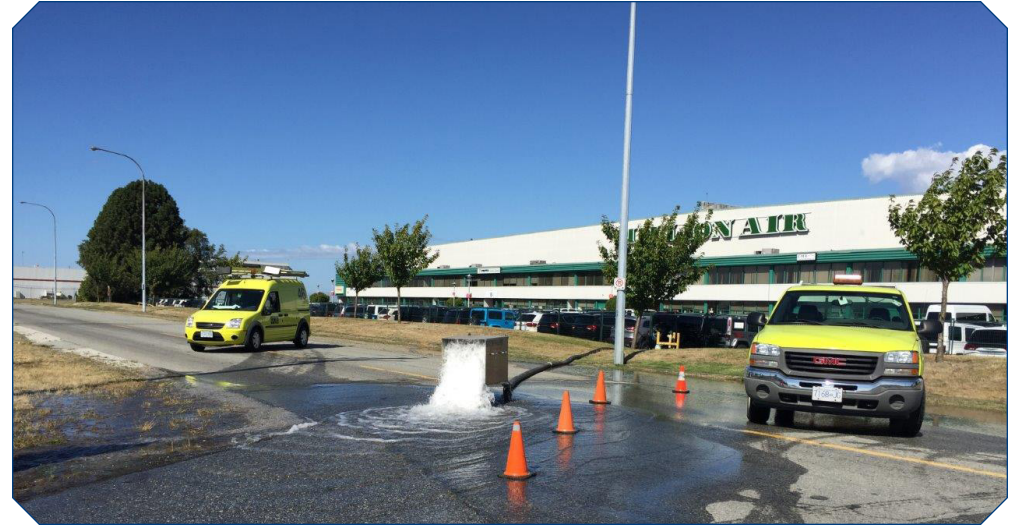
The adaptable design of the Sahara tool allowed for a horizontal insertion (vertical more common) at the water meter chamber and the inspection was completed under live conditions without disruption to service, using the water meter bypass and downstream fire hydrants.

The City of Richmond assisted by removing their aging water meter and installing the flange supplied by the Sahara team for the launch of the tool. The City then took the inspection opportunity to upgrade the old meter to a newer ultrasonic model.
