# City of Saint John, New Brunswick, Canada

## CITY TAKES PROACTIVE APPROACH TO MANAGING A CRITICAL RAW WATER MAIN USING ADVANCED ROBOTICS INSPECTION TECHNOLOGY

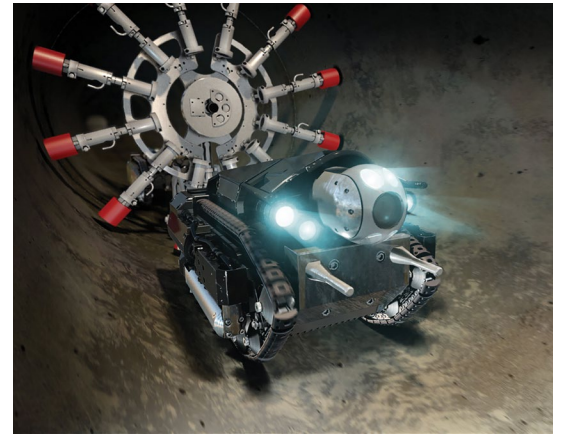
With the latest generation of robot, the speed is doubled to 25 meters (82 feet) per minute, which greatly improves efficiency in the field, a huge benefit during time-critical shutdowns like this one.
