# Xylem's smart condition monitoring device helps US-based global metal processing company move one step ahead of pump failures

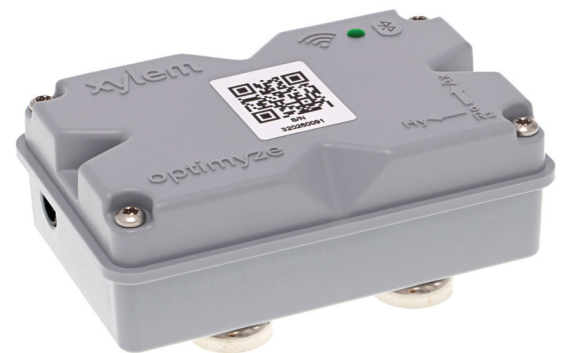
The optimize condition monitoring device monitors system vibration and temperature on rotating and fixed assets such as pumps and motors.

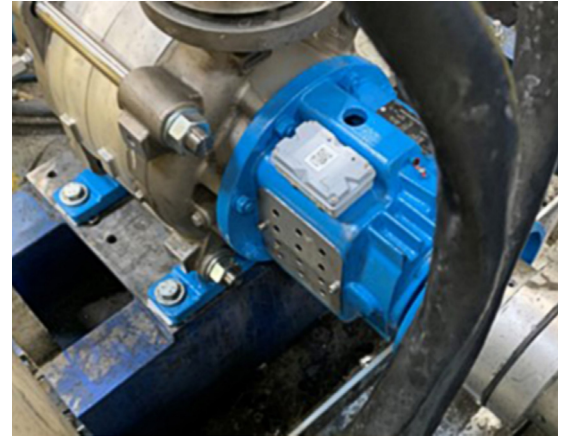
Attaching the optimize onto the e-MP led the team to successfully isolate and resolve the performance issue, preventing future operational disruptions.
