Edmonton, Canada

ALBERTA UTILITY AVERTS POTENTIAL CATASTROPHIC HOLIDAY FAILURE WITH PROACTIVE PIPELINE MANAGEMENT APPROACH

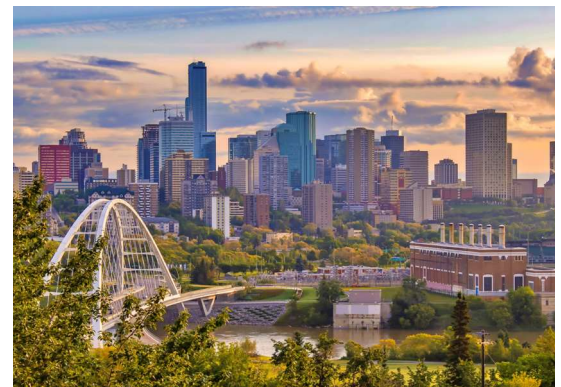
In early December 2019, as the busy and frigid holiday season quickly approached, Pure Technologies alerted EPCOR to a high-risk pipe section with both broken wire wraps and a leak on the pipe barrel. Data from both the SmartBall and PipeDiver platforms clearly showed the location of the damaged pipe between two elbows.

EPCOR conducted an emergency repair on this high-risk pipe in December 2019. Inspections identified a leak on the pipe barrel and broken wire wraps.

EPCOR weighed their options and decided to proactively repair the pipe. After excavation, Pure Technologies verified both the leak and wire wrap damage. EPCOR successfully executed an emergency repair on the pipe, averting a potential catastrophic failure just in time for the holiday season.
