Xylem's quick response restores critical water supply to North Carolina community during COVID-19 outbreak

Temporary replacement addresses catastrophic water system failure

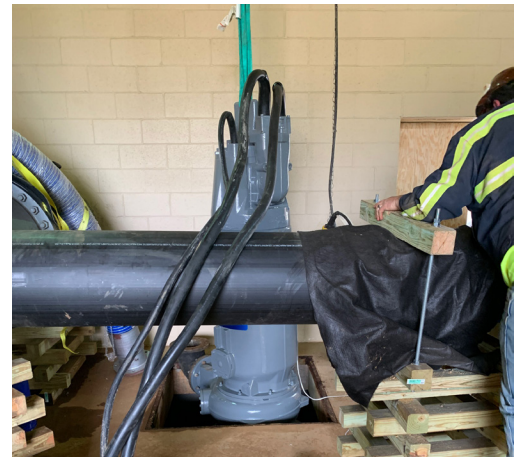
Xylem helped a North Carolina community restore water service quickly during the COVID-19 outbreak with a temporary replacement.

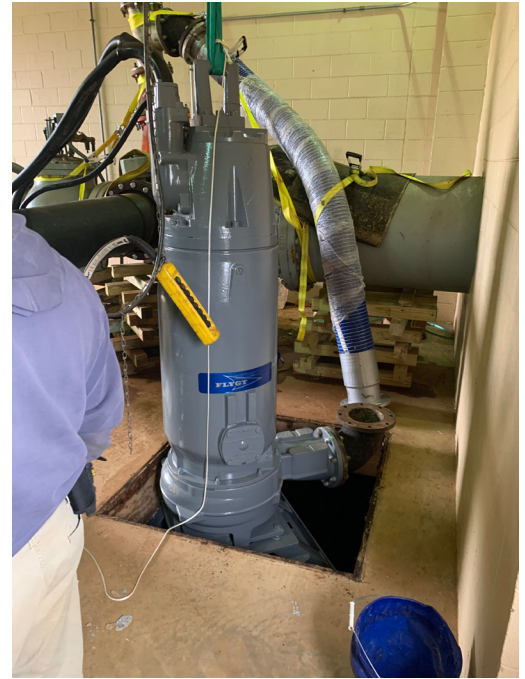
The Flygt 3231 submersible pump is lowered into the pump wet well.

After placing a call to Xylem's national rental bank in Bridgeport, New Jersey, the Flygt 3231 pump was on its way to the water treatment plant. When the pump arrived on Tuesday, March 31, a crew from Xylem arrived on site to complete the installation. Lowering the submersible pump into the vertical turbine pump wet well proved to be a tight fit. With just inches to spare, the crew dropped the pump into the opening and then turned it 45 degrees. Once the rental pump was in place and operational, the city lifted the water usage restrictions.
